UNITED STATES ENVIRONMENTAL PROTECTION AGENCY

Subject: September 1, 2017 Clean Water Act Compliance Inspection

CWA COMPLIANCE EVALUATION INSPECTION REPORT
U.S. ENVIRONMENTAL PROTECTION AGENCY, REGION 5

Date of Inspection: September 1, 2017

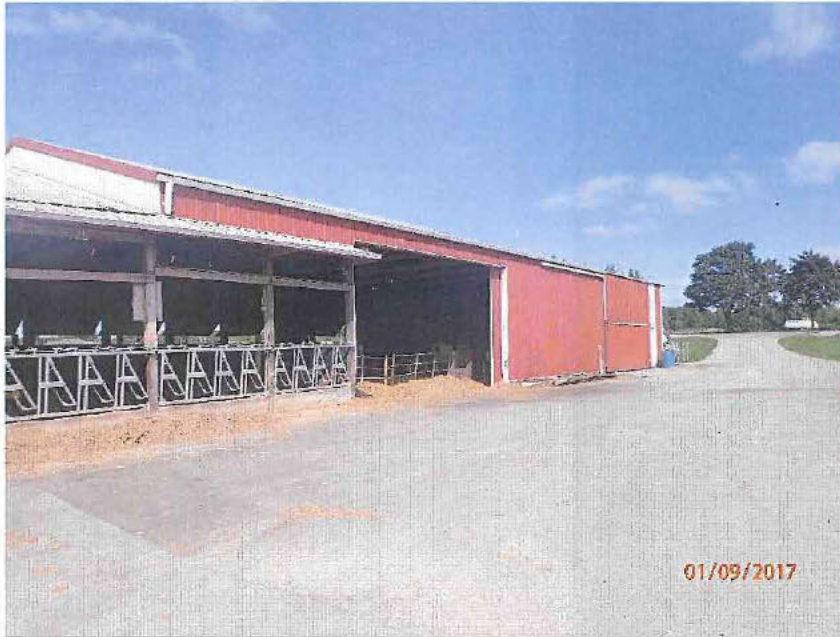
4: P9012512

Description: Machine Shed #2 and Close Up Cow Barn #1. Feed is open to precipitation but is mostly kept scraped under small overhang.

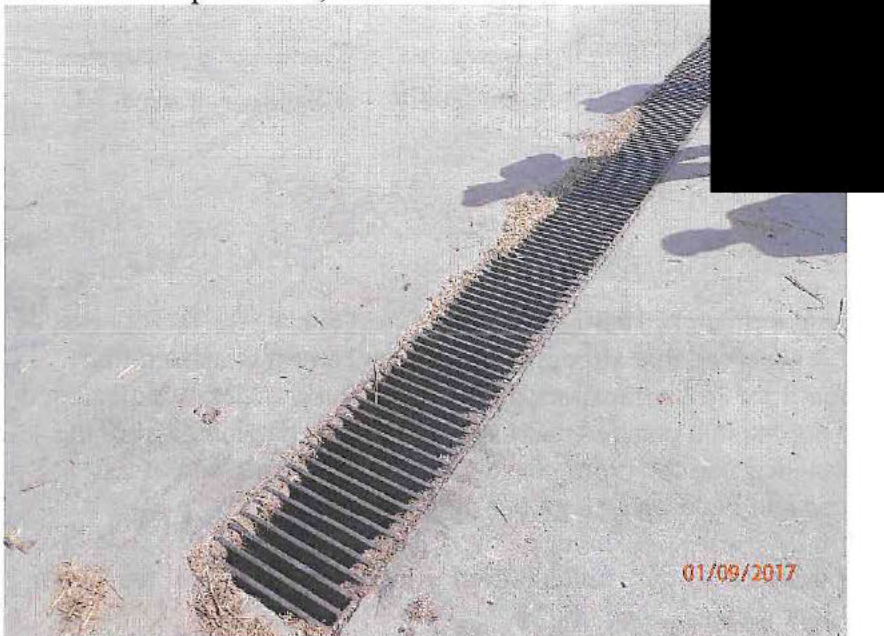
5: P9012513

EPA began the walkthrough at approximately 10:30 A.M. on the west side of the facility east of the Close Up Cow Barn #1. EPA observed that although the barn had a roof overhang that protected the feed in the feed lane from being transported with precipitation, there was feed and bedding products in and around a grate that covered a storm water gutter that went across the facility driveway. This gutter was tied into the piping for the ditch on the west side of the facility. EPA advised that the feed and bedding be kept out of the gutter.

Description: Gutter for storm water in driveway east of Close Up Cow Barn #1 has feed and bedding in the grate. Storm water from the gutter goes to the ditch on west side of facility.

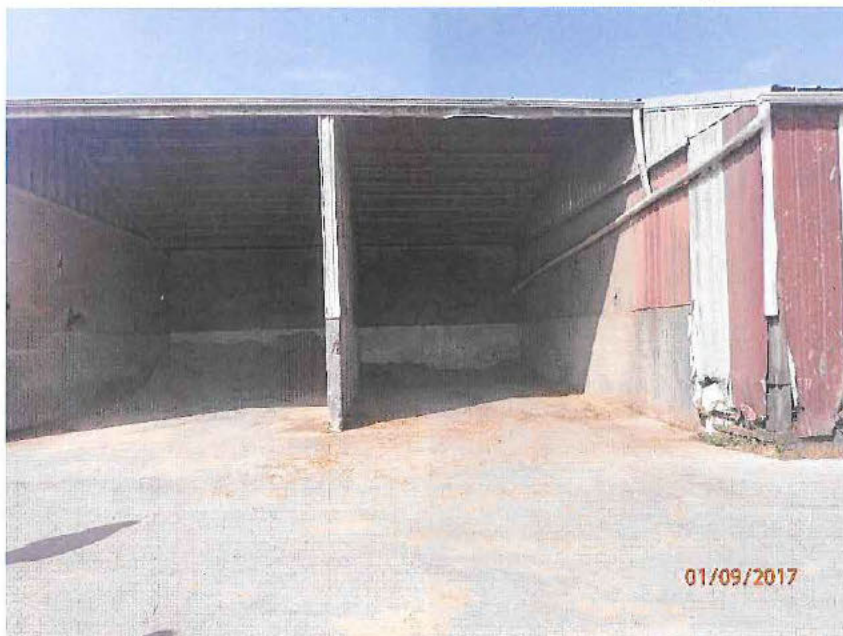
8: P9012516

Description: Small amount of track in and track out in front of the Commodity Storage.

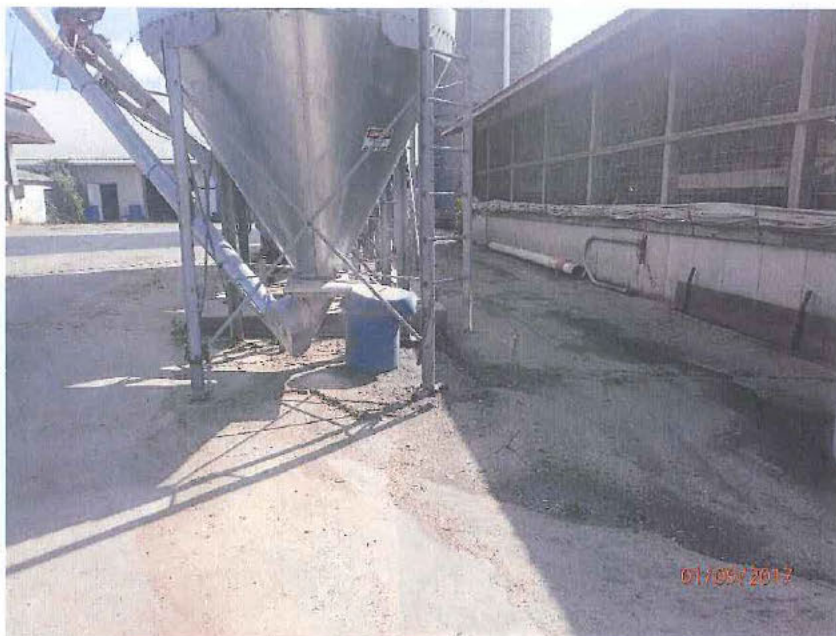
10: P9012518

Description: Small amount of feed under the bulk bins on north side of Dry Cow Barn.

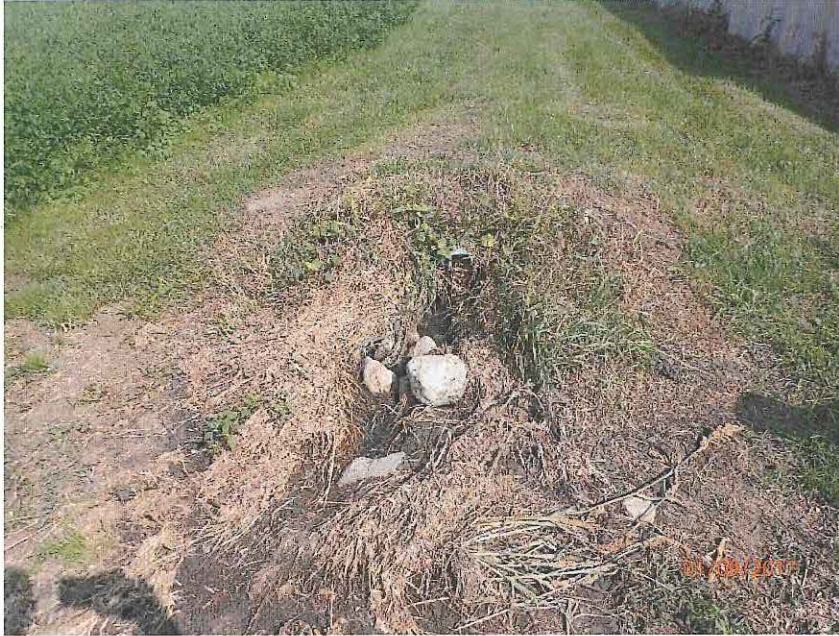
12: P9012520

- 1) From the storm water gutter on the east side of the Close Up Cow Barn to the tiled ditch on the west side of the facility. EPA observed straw bedding on the ground around the storm water gutter intake that was similar to the straw that was partially clogging the outlet of the tile pipe.

A formerly open ditch on the west side of the facility had been tiled. The outlet of the tile was along the former ditch pathway, just to the west of Bunker #7. EPA observed that the pipe outlet was partially clogged with straw that was similar to the straw bedding observed at the storm water gutter.

Description: Outlet of piped ditch on west side of facility. End of pipe is partially clogged with straw.

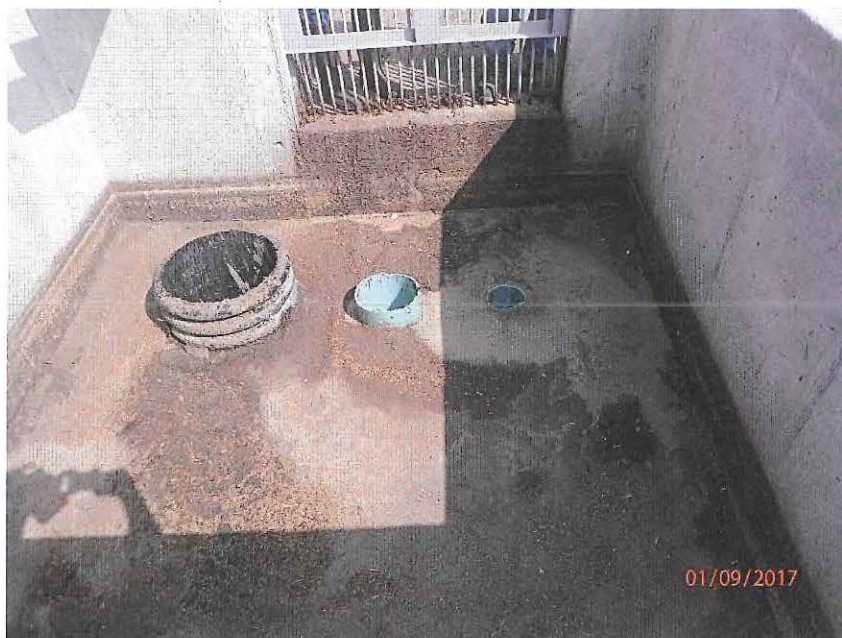
20: P9012528

The largest/tallest pipe directed any process wastewater that reached its level directly to the ditch on the west side of the facility as a bypass. The pipe was calculated to only take flow that exceeded the amount of a 25-year/24-hour storm and a 35 foot buffer was retained in the ditch below the outlet of this pipe. EPA observed the outlet of this pipe and noticed that the water beneath the pipe was darkly colored.

Description: Collection pit with three pipes.

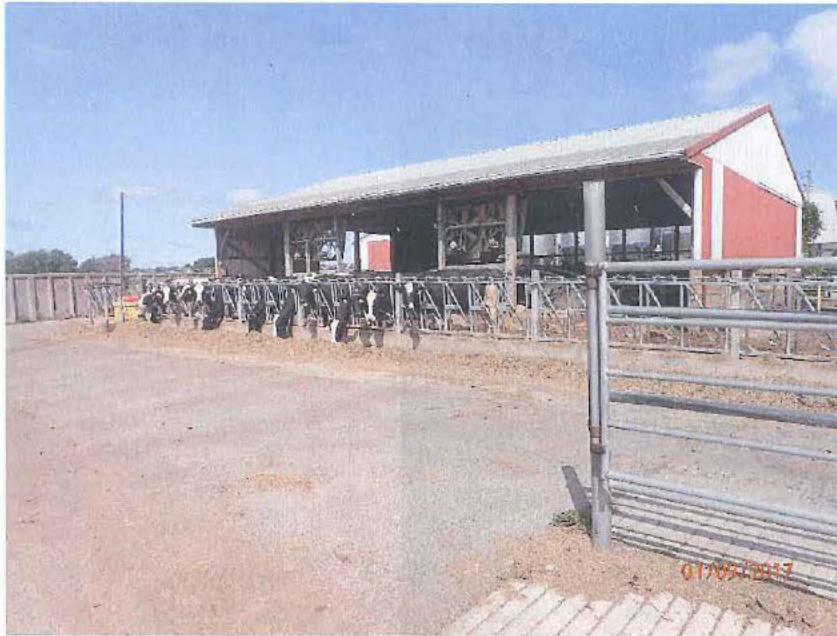
44: P9012552

Description: South side of Dry Cow Barn. Feed is open to precipitation and would flow to the south to the collection pit at the southwest corner of the Feed Storage Pad.

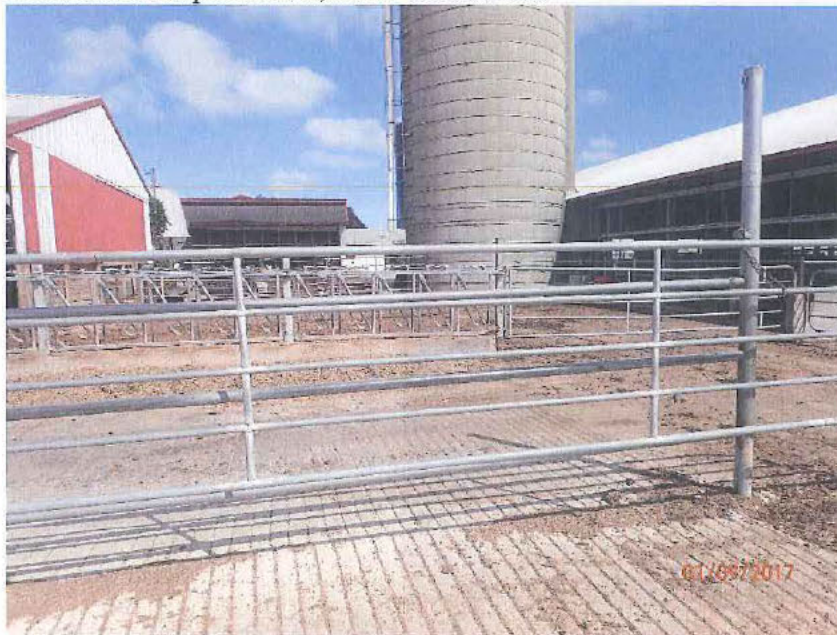
45: P9012553

Description: Cattle Walkway is open to precipitation. Manure and process wastewater would flow to the south to the Dry Cow Feedlot and then the south into Pasture #2.

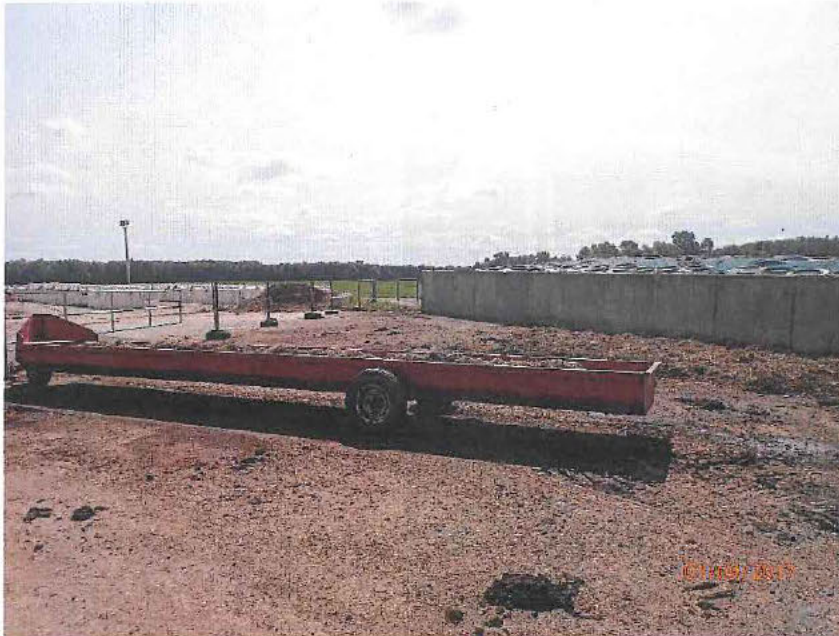
46: P9012554

EPA also observed the superhutches and Calf Hutch Pad had no containment for manure or process wastewater. All the manure and process wastewater from these three areas would flow to the south to Pasture #2. Heavy precipitation could carry these pollutants to the unnamed perennial stream. The transport of the process wastewater through Pasture #2 would also be aided by the flow out of a storm water pipe that discharges storm water from the north side of the facility to the north end of Pasture #2.

Description: Dry Cow feedlot does not have any containment for manure or process wastewater.

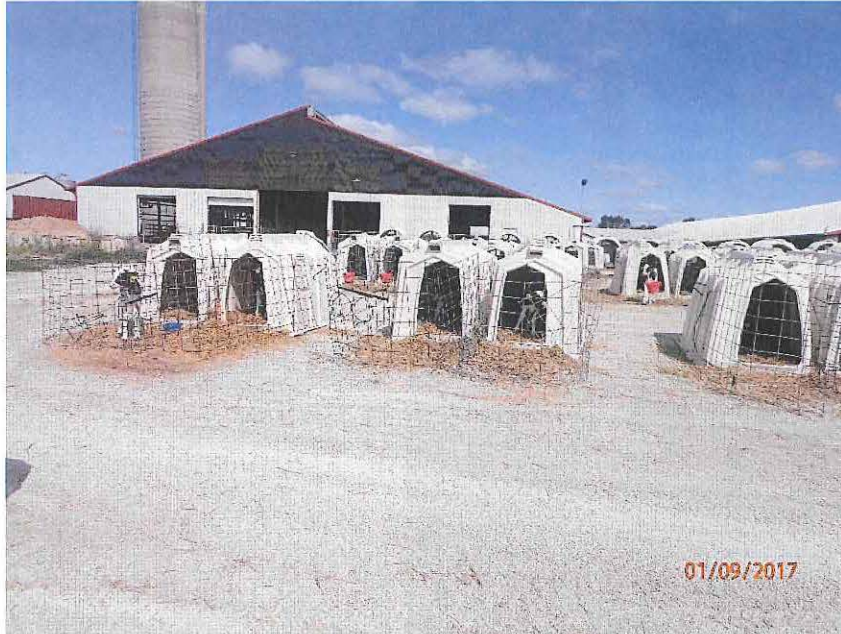
50: P9012558

Description: Manure and process wastewater from the Calf Hutch Pad is not contained.

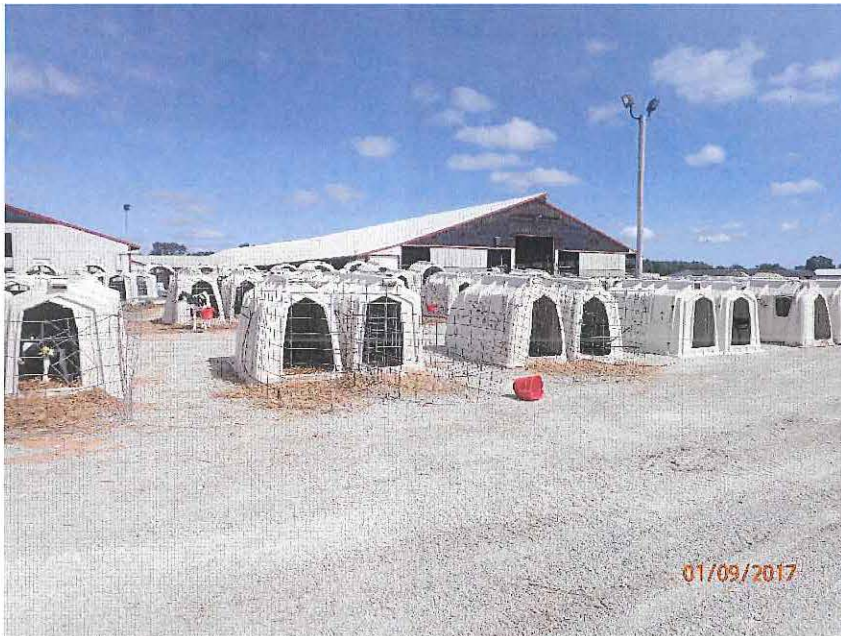
51: P9012559

Description: Manure and process wastewater from the Calf Hutch Pad is not contained.

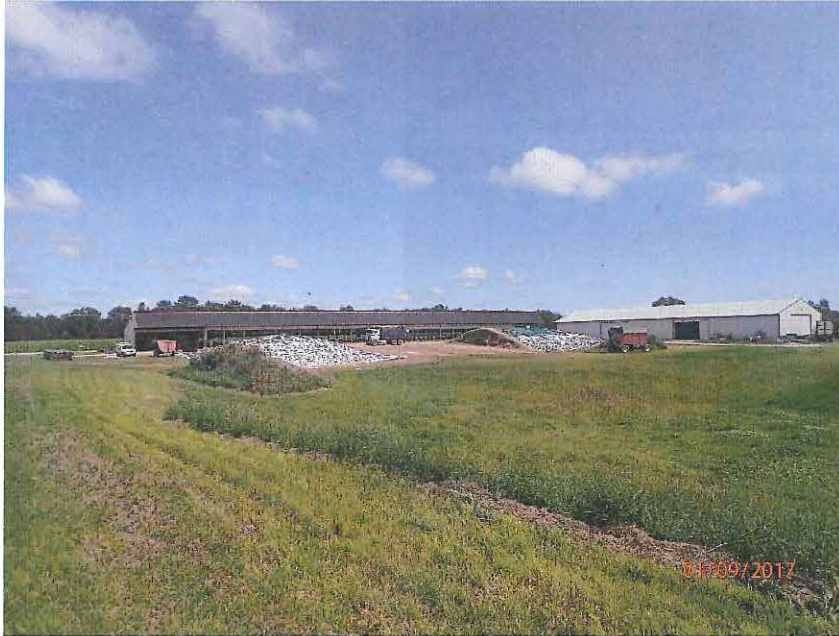
65: P9012573

EPA then walked east to the Calf Barn and observed the silage pile that was stored on the ground to the south of the barn. The silage was tarped and only had a minimal amount of feed around the pile. Process wastewater from the silage would flow to the south to a crop field. The land in this area was flatter and EPA did not observe any flow pathways in the field that would indicate that the process wastewater from the silage would reach all the way to the south to the unnamed perennial stream.

Description: Silage stored on the ground south of the Calf Barn.

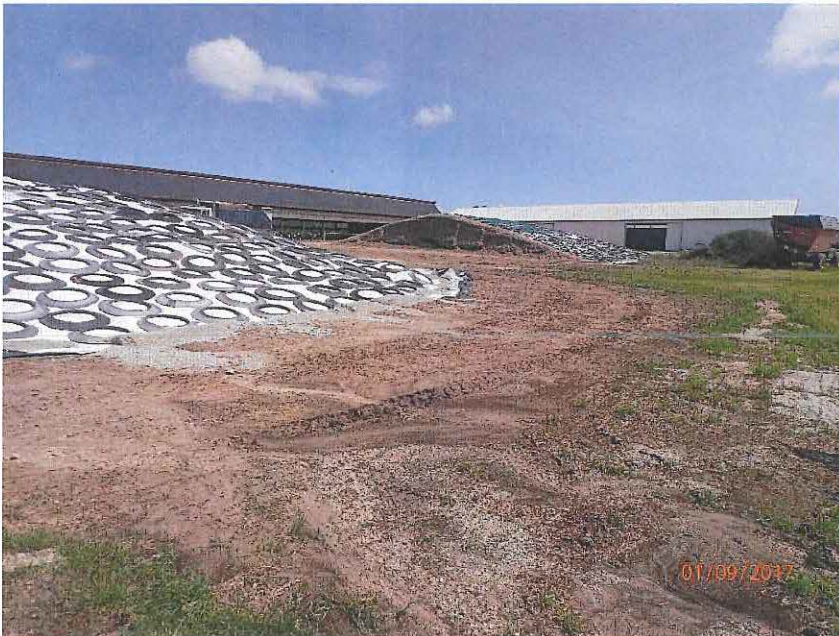
66: P9012574

Description: Precipitation can transport silage to the south to a crop field.

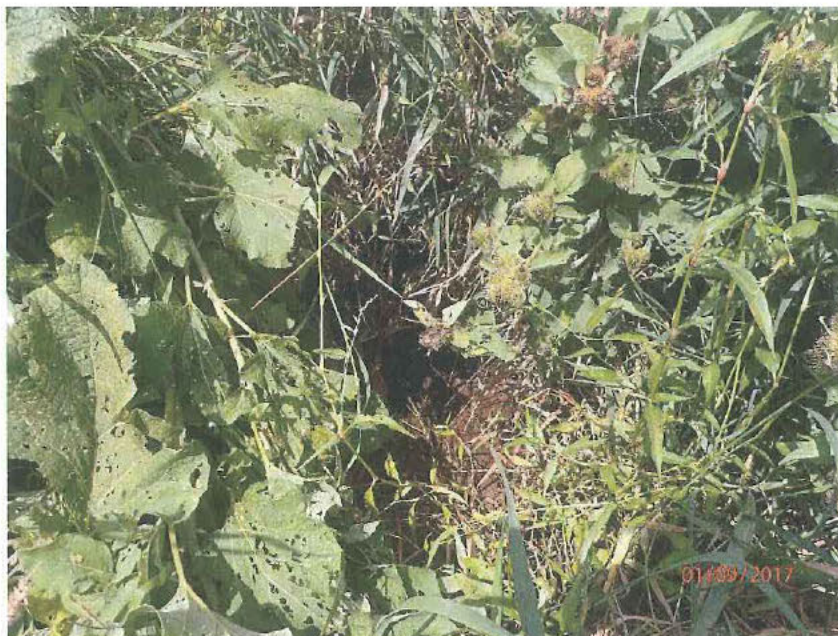
67: P9012575

Description: A small amount of flow channelization in the field to the south of the Calf Barn.

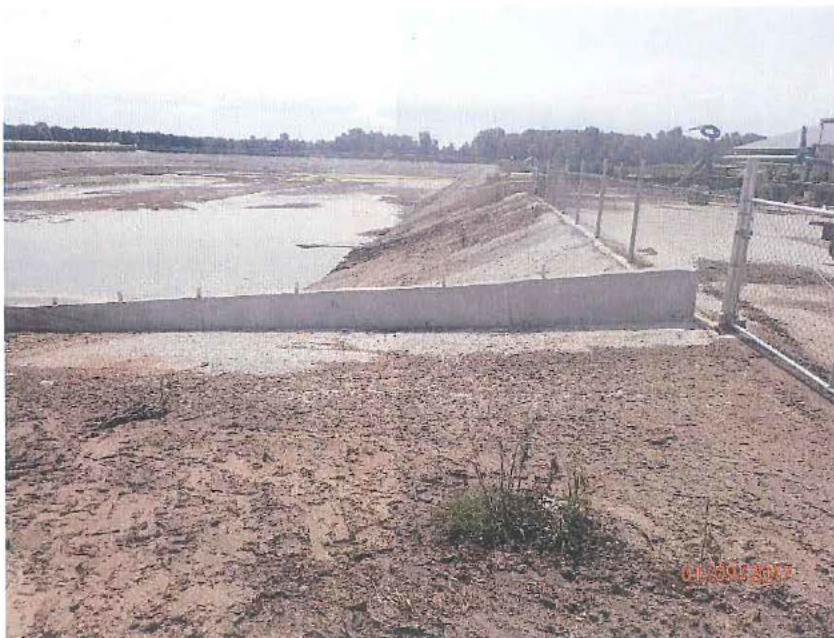
80: P9012588

Description: Although there are depth markers installed in the concrete, none of them are marked to show where the maximum operating level (MOL) is.
